Tahoe Certified Home Inspections, Inc.

ALOHA RD. S. LAKE TAHOE, CA

INSPECTION REPORT

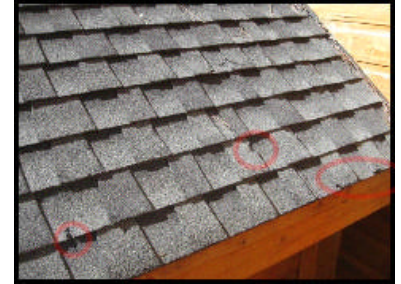
3.7 ROOF COVERING STATUS: Minor damage is noted to a few of the shingles along the eaves. This condition is a result of snow and ice buildup. Annual inspections and periodic repair are recommended to help ensure the water tight integrity of the roof covering.

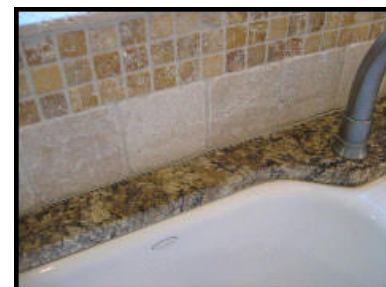
- 5.1 WALL FINISH: Paint and tile condition is Good.
- 5.2 FLOORING: Tile condition is Good.
- 5.3 WINDOW(S): Dual pane.
- 5.4 DOOR(S): Good.
- 5.5 LIGHTING: The pantry light is missing the bulb and cover.
- 5.6 OUTLETS: Functioning as designed.
- 5.7 GFI OUTLETS: GFI outlets are installed and working as designed.
- 5.8 HEATING DEVICE: Heat register.
- 5.9 CABINETS: Good.
- 5.10 COUNTERTOPS: Granite condition is Good. Settling cracks are noted in the backsplash grouting. Re-caulking this area is recommended.

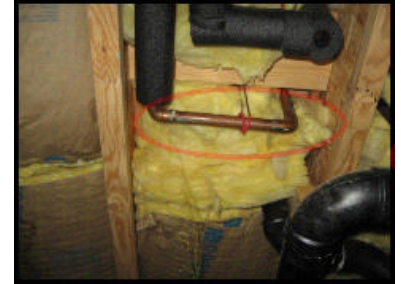
**11.7 WATER PIPE
TYPE:**

Copper. Supply lines which are not visible are not part of these conclusions. Most of the water pipes located in the crawl space are insulated. Fully insulating the pipes is recommended.
